**PHASE I ENVIRONMENTAL
SITE ASSESSMENT**

**SKYSERVICE AIRLINES INC.
31 FASKEN DRIVE
ETOBICOKE, ONTARIO**

July 2007
Reference No. 07-0122

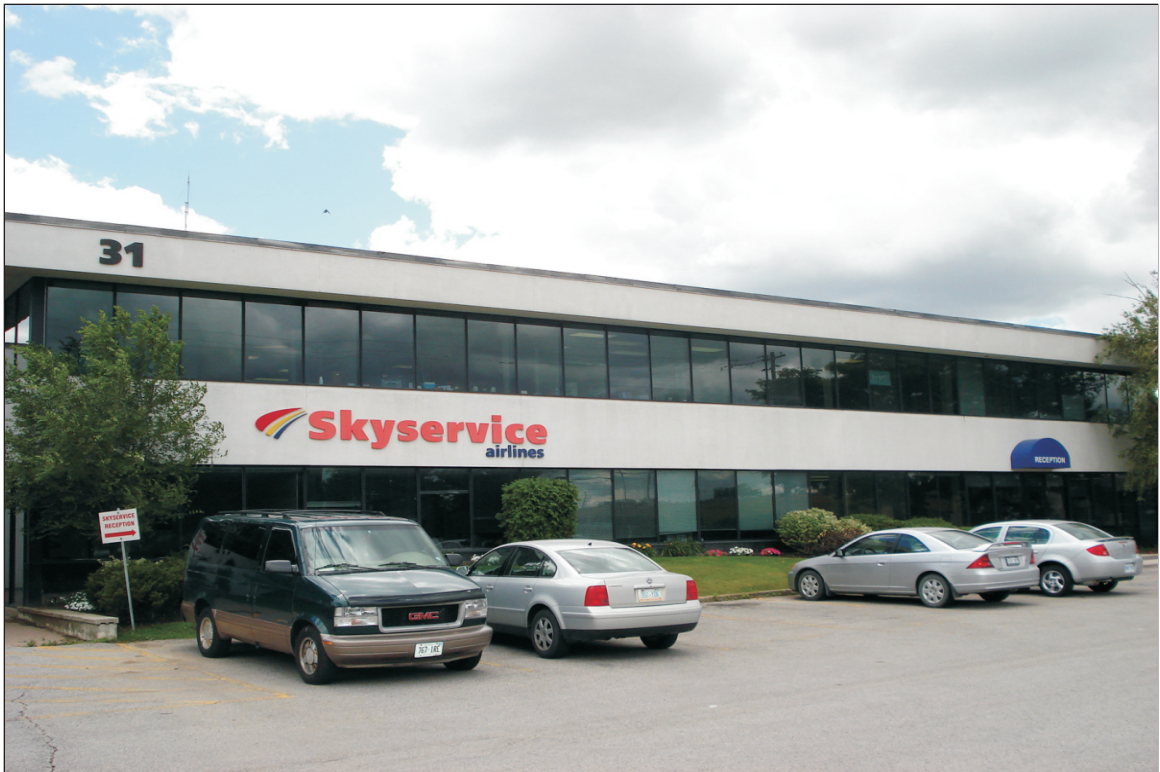
Photograph 1: View of the Site, looking south.

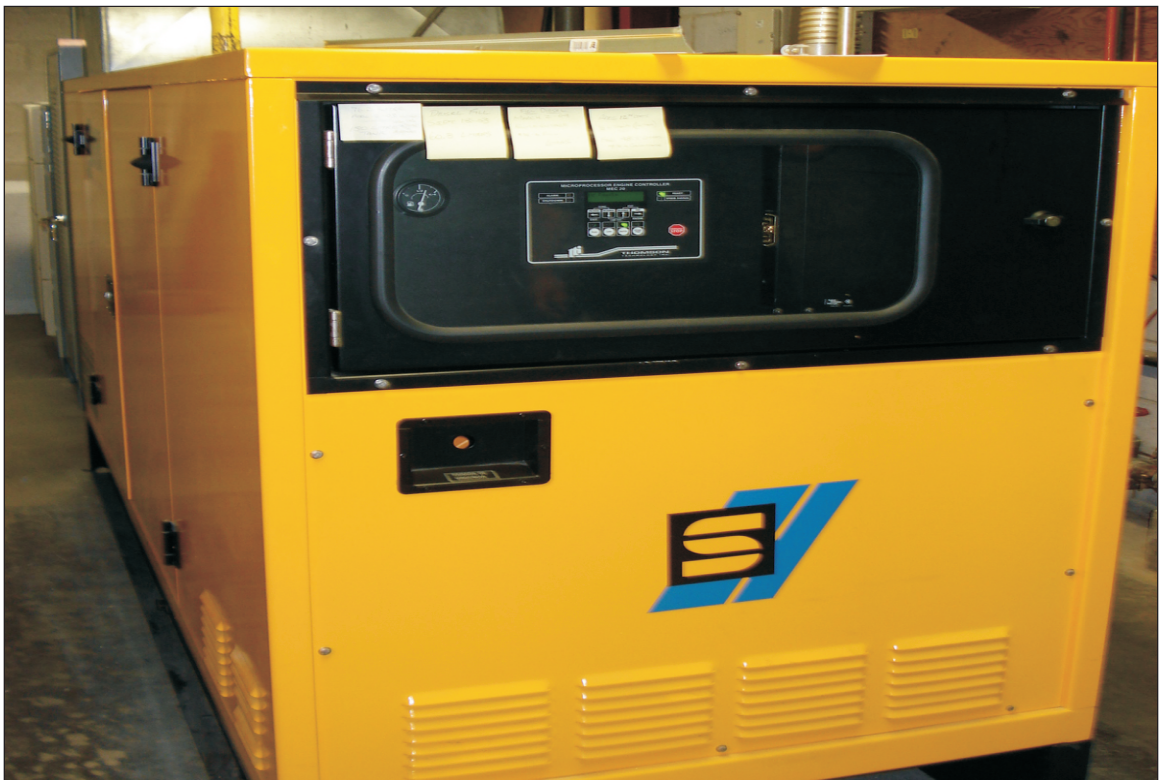
Photograph 2: View of the diesel-fired emergency generator located in the generator room on the first floor.

According to the Site representatives, an 80-litre above ground storage tank (AST) containing diesel is fully-contained inside the casing of the diesel-fired emergency generator located in the generator room on the first floor of the Site building (Photograph 2). At the time of Watters Environmental Site reconnaissance, the generator casing was not accessible and thus could not observe the tank. Watters Environmental did not observe any staining or evidence of leakage in the vicinity of this generator.

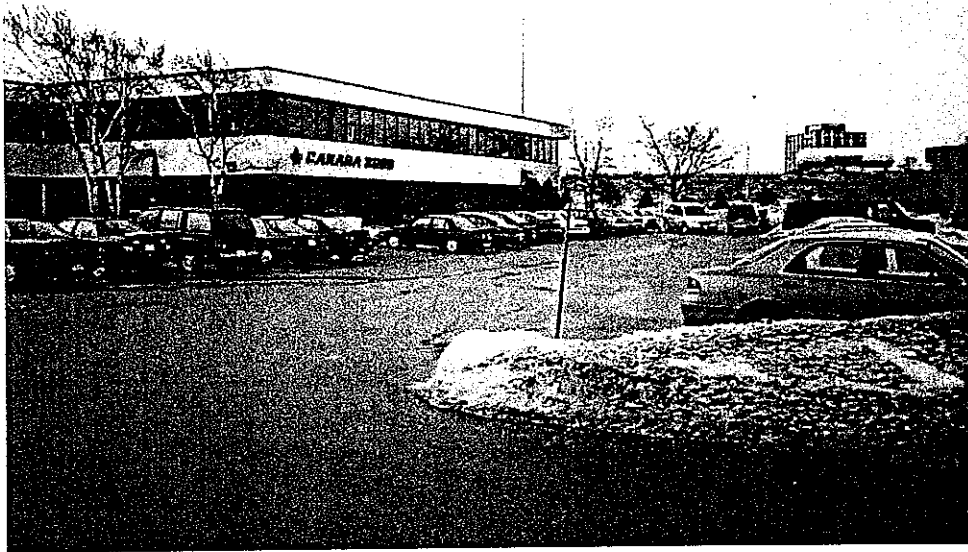
1

View of north side of building looking southwest.
Truck in background is on Highway 427 overpass.

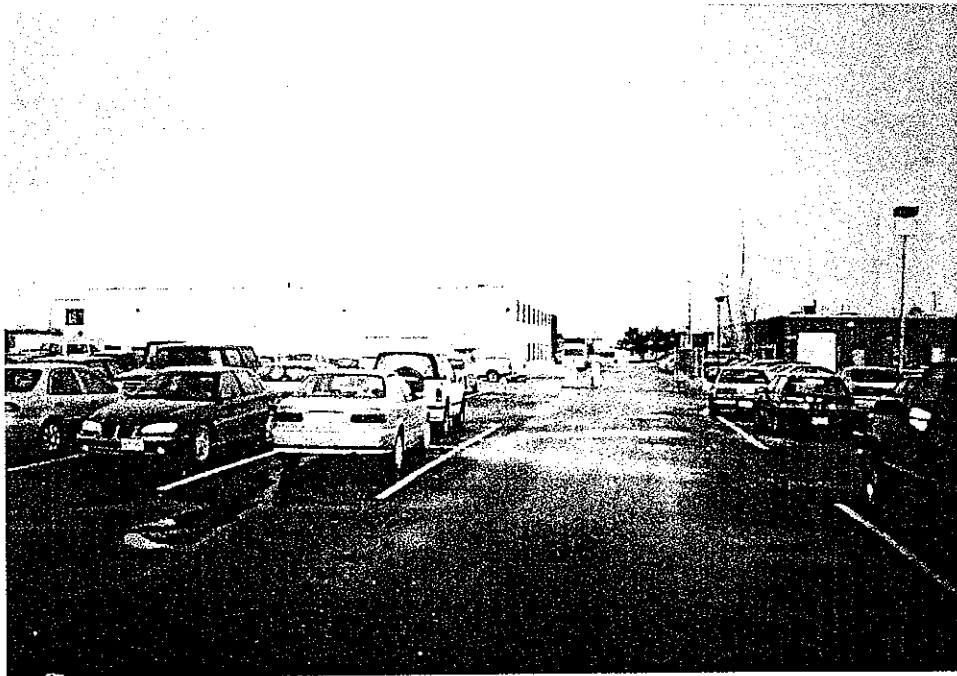
2

Looking north along east side of property from the parking lot towards
the warehouse portion of the building.

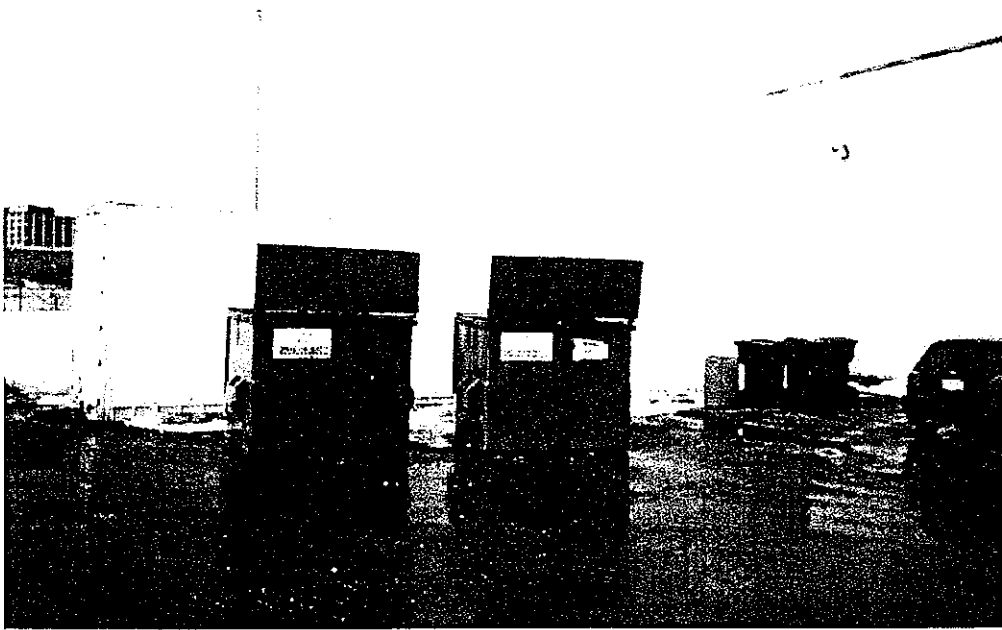
3

Waste bins and trailer located to the south of the building (view looking west).

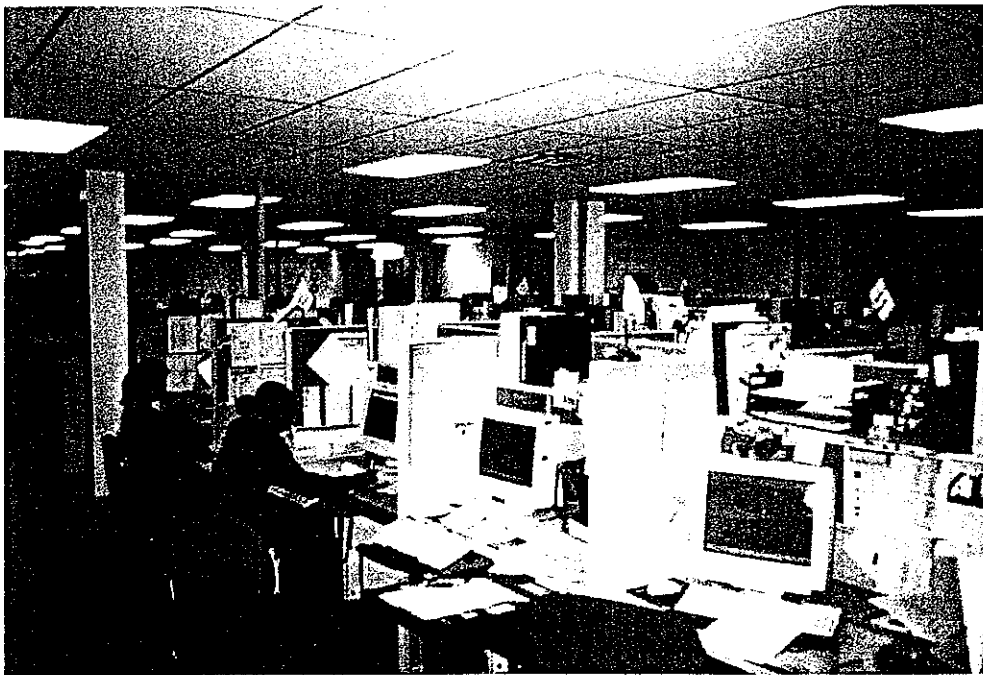
5

General view of the office area.

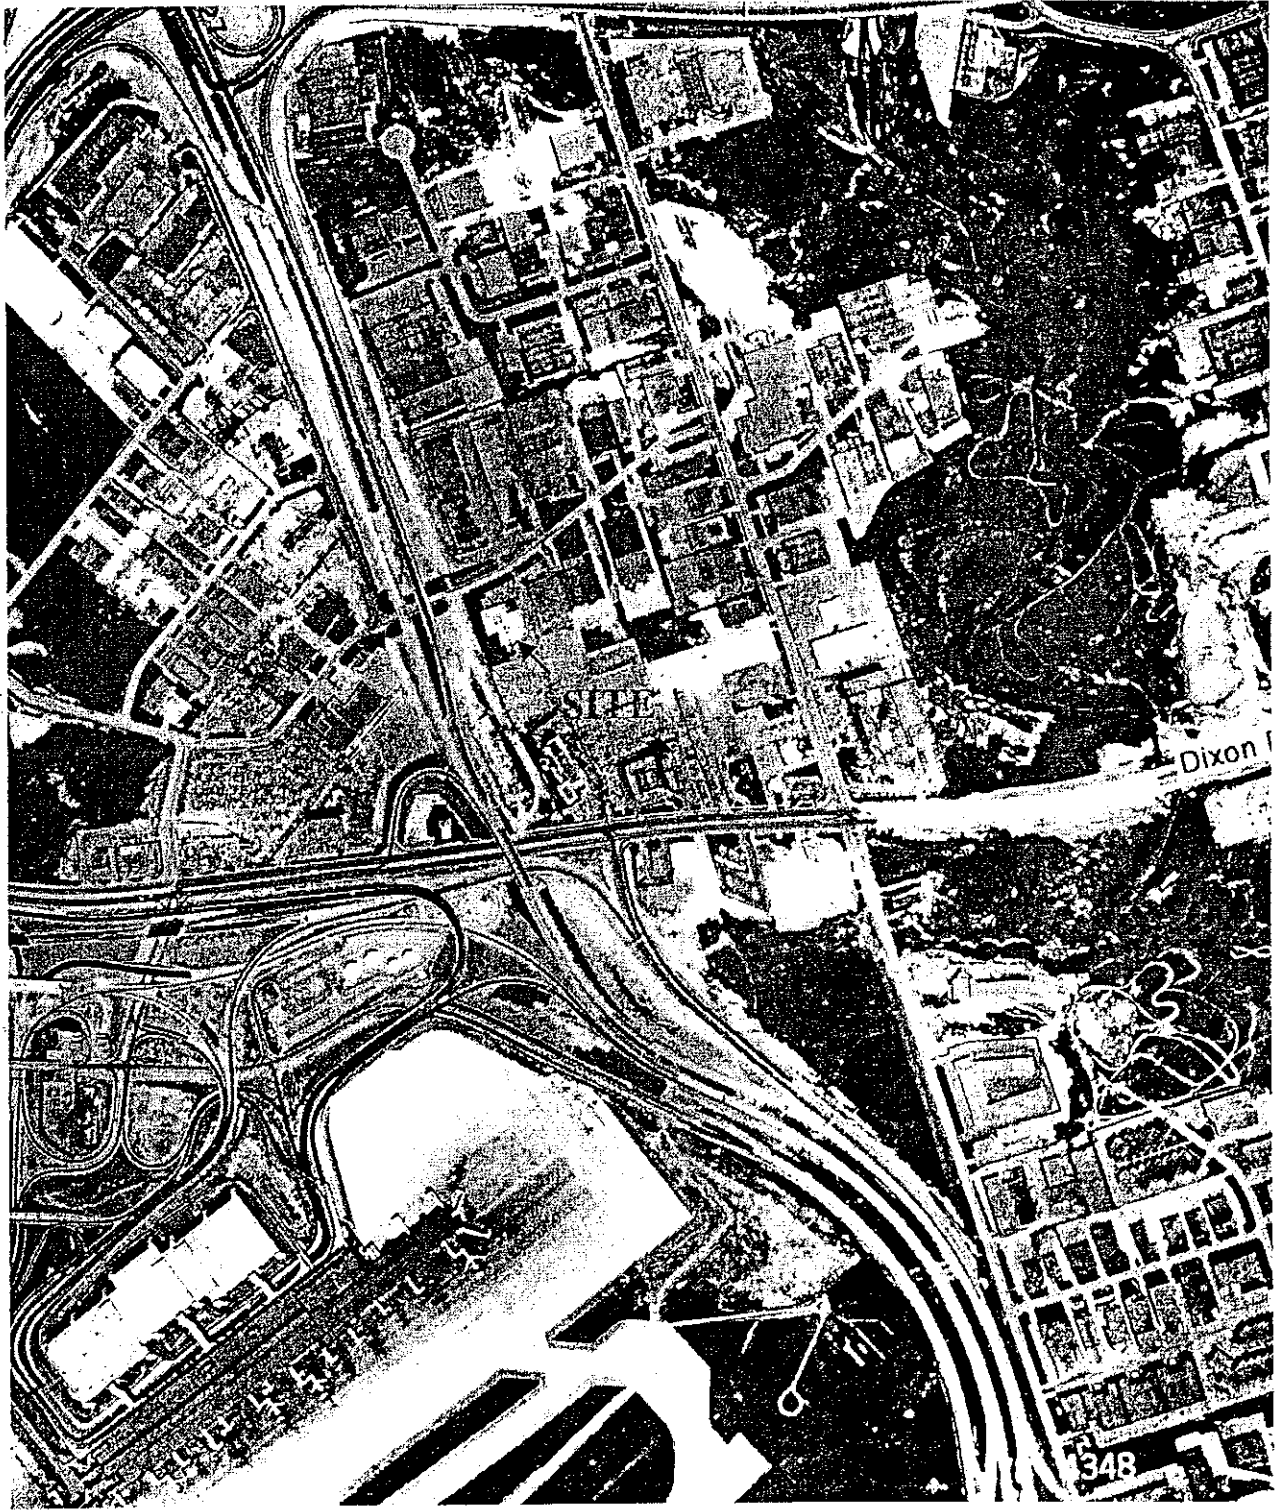
APPENDIX C
1978 AERIAL PHOTOGRAPH

SHAHEEN & PEAKER LIMITED		
	Scale: ~1:10 000	PHASE 1 ENVIRONMENTAL SITE ASSESSMENT	
	Date: February 1, 2001	31 FASKEN DRIVE	
	AERIAL PHOTOGRAPHY: 1978		
Project: SP3711	TORONTO, ONTARIO		Drawing No. C1

According to the historical aerial photographs reviewed, the following information was noted with regards to the Site:
